9230-05-1093

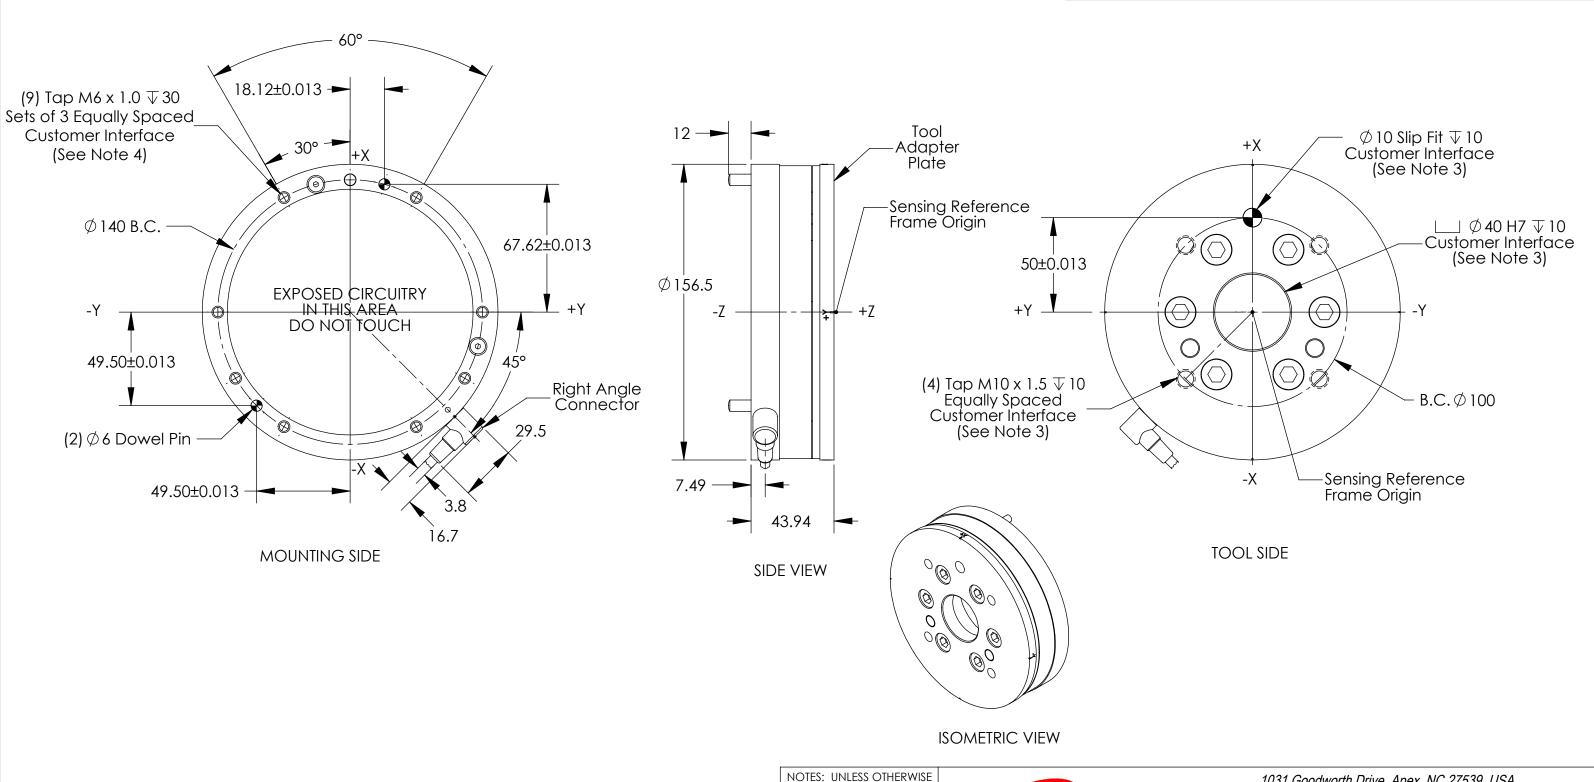
- Material: Hardened Stainless Steel and Aluminum
- Do not touch internal electronics or instrumentation.

- This could damage the transducer and will void the warranty. **DO NOT EXCEED INTERFACE DEPTH, MAY CAUSE DAMAGE.**No threads present first 13mm of interface.

For best accuracy, transducer must be mounted to surfaces rigid enough to support loads without deflection.

Eco 7882; Changed dowel hole depth on customer interface from 12 to 10; Added B.C. 100 dimension. Updated Notes and Title Block.
